**Re: Change of Owner, Guarantor, and Operator for the Las Flores Pipeline System (Formerly AAPL Lines 901/903)**

**Failure Investigation Report**

Plains Pipeline, LP - Failure Investigation Report  
Santa Barbara County, California Crude Oil Release - May 19, 2015

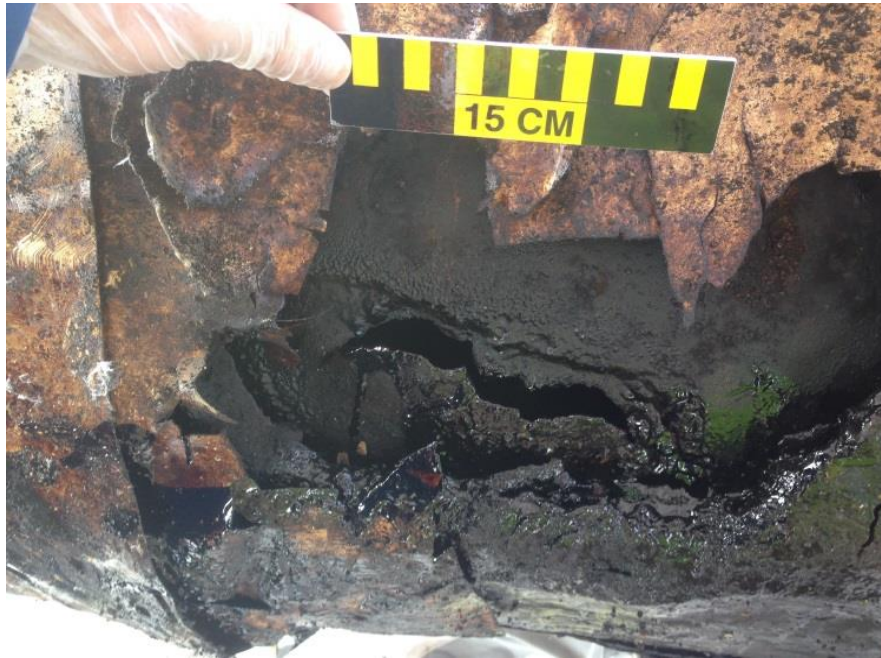
**Figure 4.** The failed pipe and surrounding insulation and coating.

“The results of the metallurgical analysis indicate that the leak occurred at an area of external corrosion that ultimately failed in ductile overload under the imposed operating pressure. The morphology of the external corrosion observed on the pipe section is consistent with corrosion under insulation facilitated by wet-dry cycling.”<sup>xi</sup>

PHMSA determined that the proximate or direct cause of the release was progressive external corrosion of the insulated, 24-inch diameter steel pipeline. The corrosion occurred under the pipeline's coating system, which consisted of a urethane coal tar coating applied directly to the bare pipe, covered by foam thermal insulation with an overlying Polyken tape wrap. Water has been noted in the foam insulation at a number of digs, indicating that the integrity of the coating system had been compromised. The external corrosion was facilitated by the environment's wet/dry cycling, as determined by the PHMSA-approved, third-party metallurgical laboratory. The release was a single event caused at an area where external corrosion had thinned the pipeline wall. There is no evidence that the pipeline leaked before the rupture. There was a telltale "fish mouth" (a split due to over-pressurization) at the release site indicating the line failed in a single event.

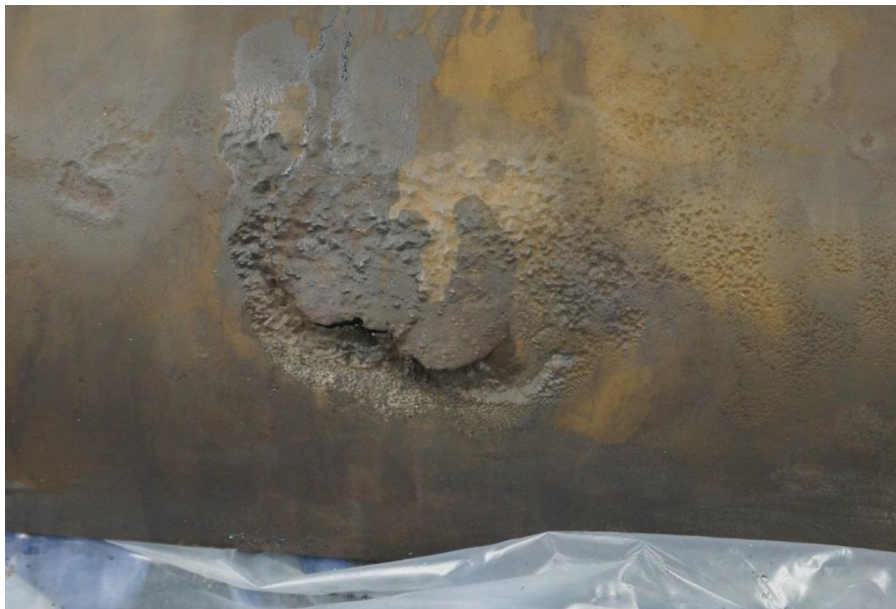
**Figure 5.** Pipe External Surface at the Line 901 failure site after cleaning.
